Craig Phadrig Hillfort, Inverness

Archaeological Evaluation

Data Structure Report

AOC Project Number: 70011

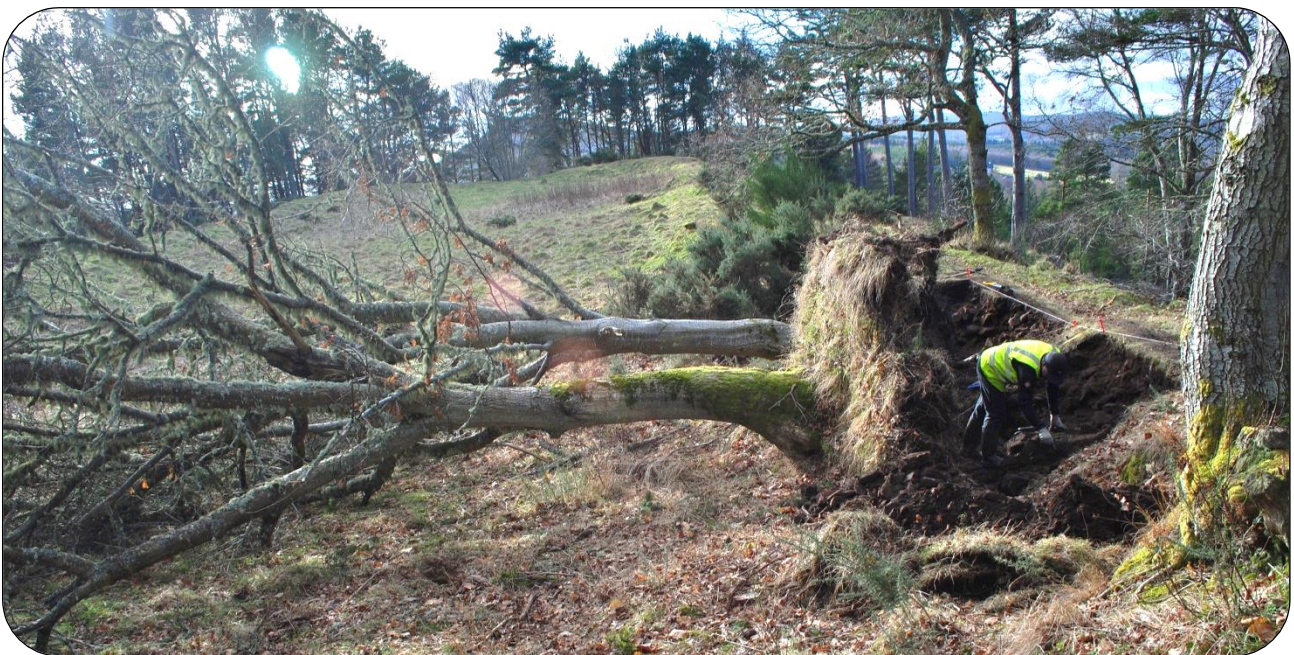
Plate 1: Looking SE across the hillfort interior showing the location of the tree erosions

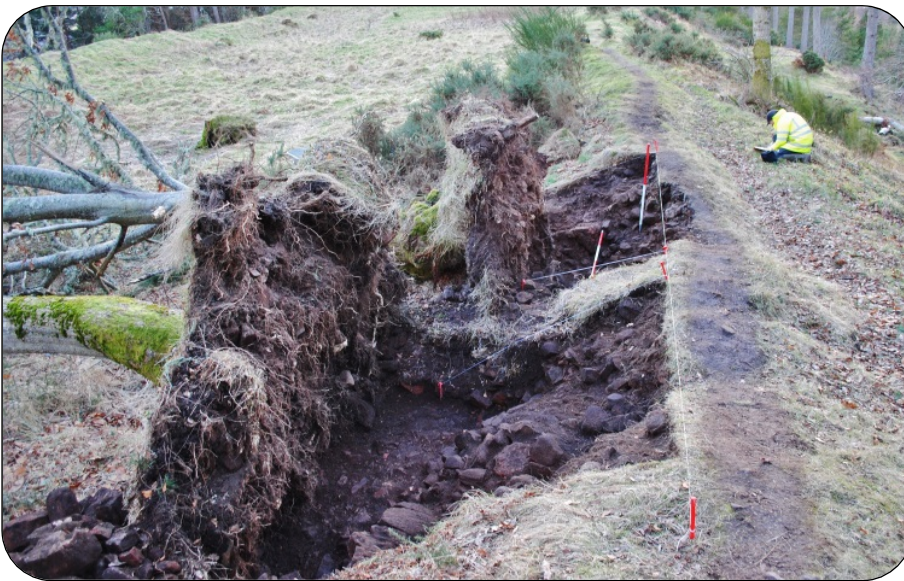
The wind damage to the site was caused by the uprooting of two windblown trees in the north corner of the main rampart (Plates 3-4). The fallen trees exposed an area of the inner rampart core measuring 7.5m NE-SW by 2m NW-SE. Loose soil, tree roots and rampart debris were removed from the exposures and sections were cleaned back for recording.

Plate 3: Looking SW over the tree exposures after clean-back

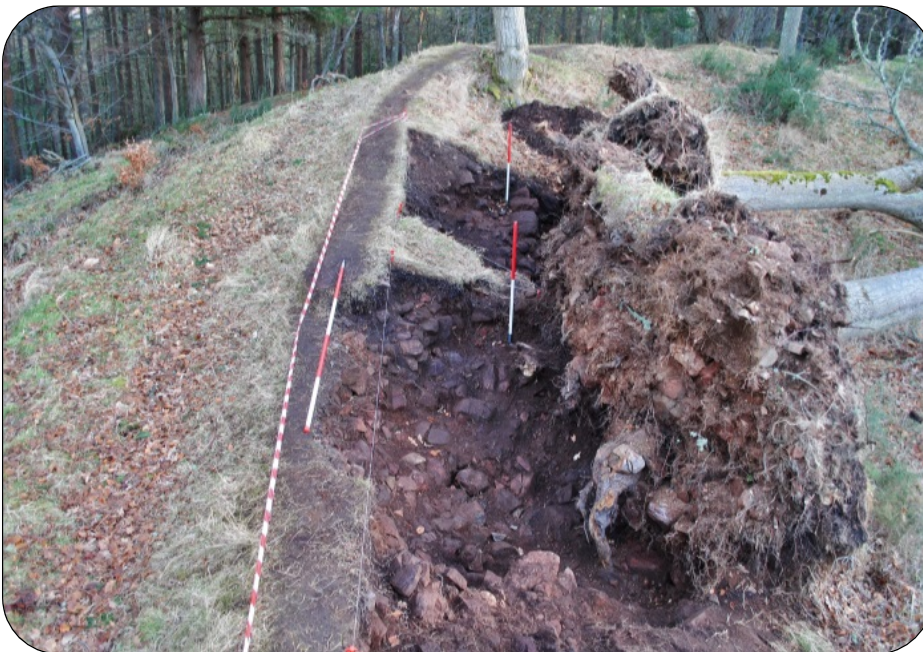
Plate 4: Looking NE over the tree exposures after clean-back

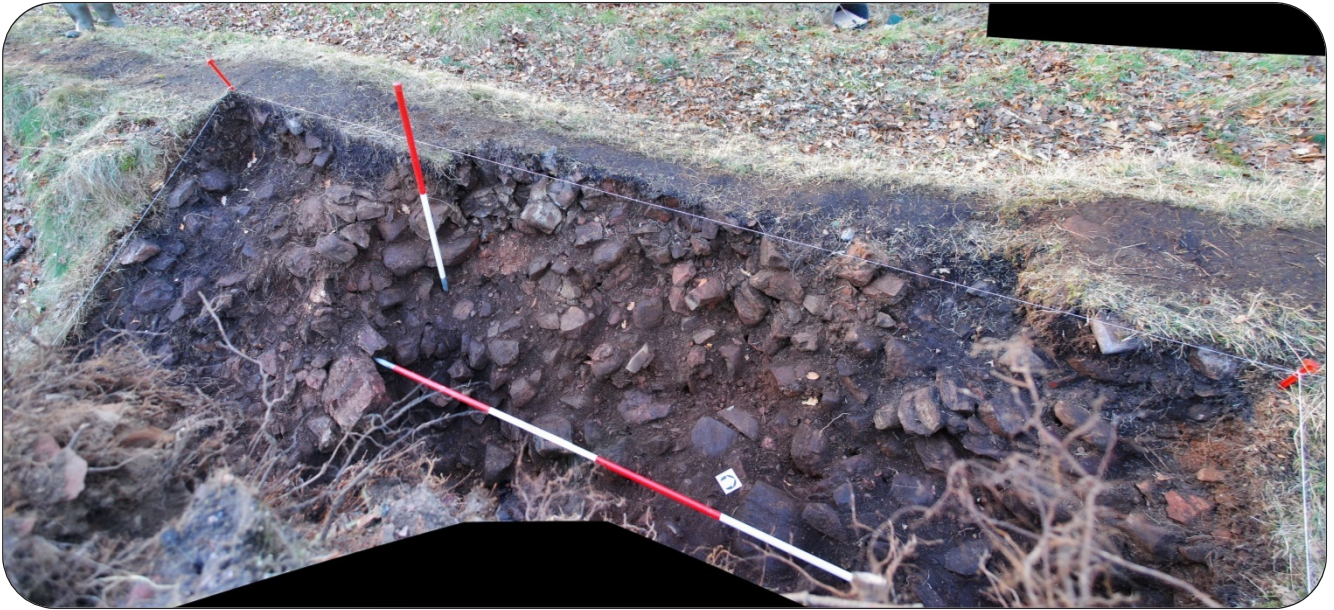
The cleaning and partial excavation of the northeast and southwest tree exposures allowed for assessment of the damage to the rampart (Plates 5-7). The tree exposures resulted in the loss of approximately 2-2.5m of wall core on the inside of the rampart along a distance of 7.5m. The damage disturbed any possible structural features with the exception of a short section of boulder kerb that survived at the northeast end (Plate 6). This was initially thought to be the inner rampart wall but was later shown to be the interior kerb (029) of the upper rampart bank (008). The exposures also exposed the loose inner core of the upper bank and main rampart, which contained a significant amount of heat-affected stone, some of which was vitrified. The damage from the root disturbance removed any further identifiable features and there were no further archaeological deposits and no artefacts identified within the exposures.

Plate 5: Looking W over the tree exposures after clean-back

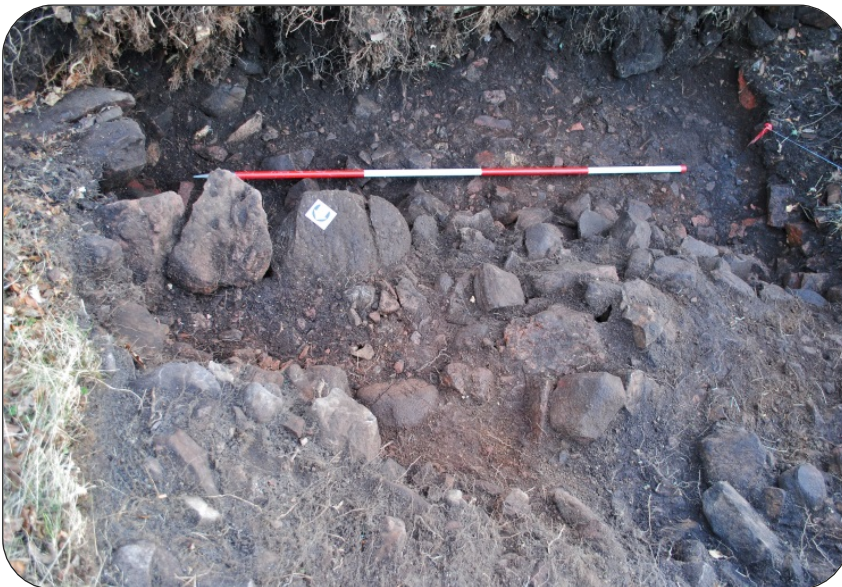
Plate 6: Looking SE over the NE exposure, showing the kerb [029] below the 2m scale pole

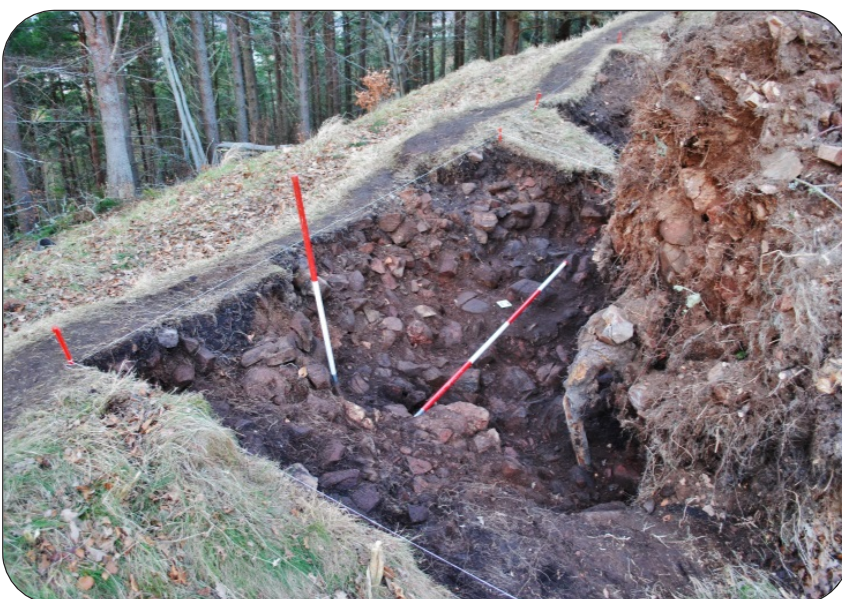
Plate 7: Looking N over the SW exposure showing the wall core of the upper bank

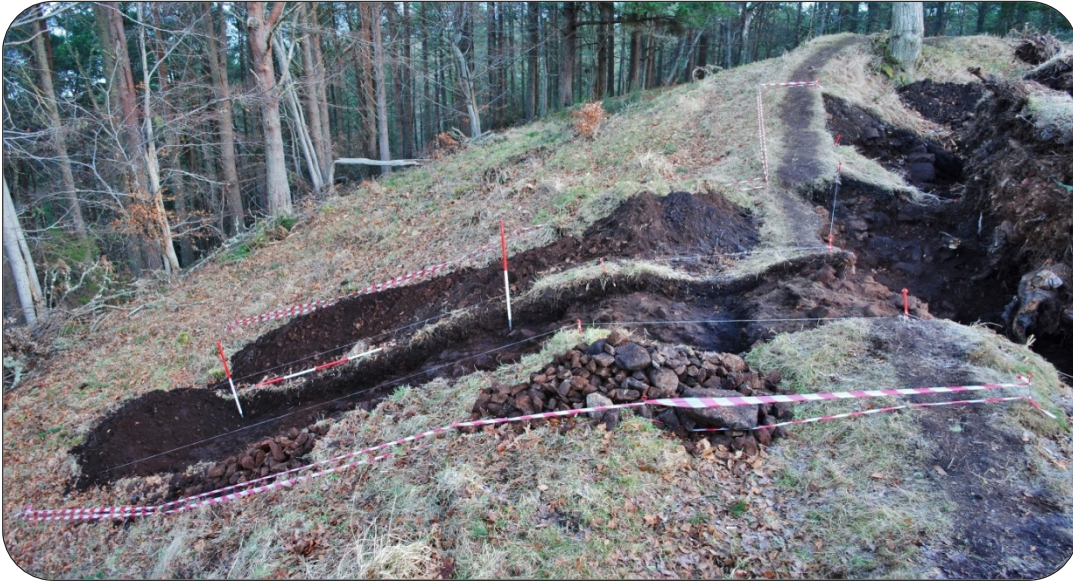
Two banks of material, [008] and [009] were identified on the upper rampart surface (Plate 8). The banks, which comprised a mixture of heat-affected and unaffected stone/sand fill, were separated by a deep, 'V'-shaped ditch [022] that had cut into the top of the primary rampart. The fill of the ditch [007] was packed with stones at the base and contained substantial charcoal fragments. This led to the interpretation that it had formed a slot for timber posts forming a palisade on the top of the rampart. Possible small post settings [004] and large post settings [018] and [019] were recorded within the base of the ditch (Figures 4-6, Plates 9-10, 12-13, 15).

Plate 8: Looking NE over the rampart after initial excavation; in the centre of the image the upper banks of material are visible, [009] to left and [008] to right

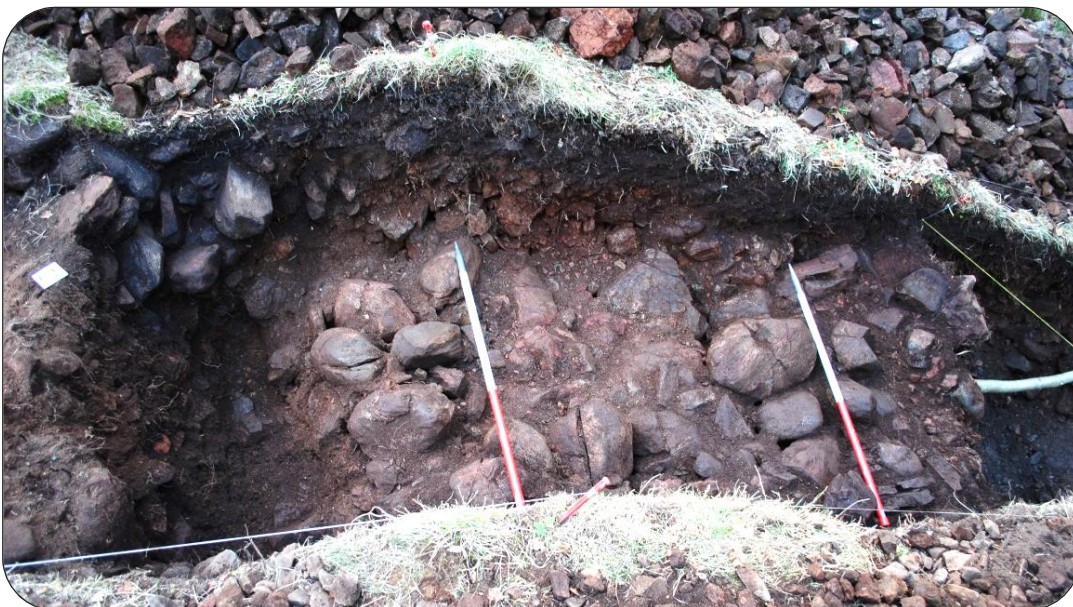
Within the primary rampart core, visible below outer bank [009], there were possible alignments of large, heat-affected and partially vitrified boulders in the core [021] (Plate **11**). Concentrations of vitrified stone [030] within this layer demarcated areas where burning on the main rampart was more intense and this may relate to the location of vertical timber lacing within the rampart at the time of burning. Similar concentrations noted within the inner bank [008] core were also thought to relate to in situ timber burning. Interestingly, the underlying rampart core [015] in this section contained a few small fragments of burnt bone and a possible pit [034] within this layer may relate to a primary feature on the rampart or may be the result of soil infill during secondary re-structuring of the rampart.

Plate 11: Boulder alignments within the core of the main rampart [021], looking SW

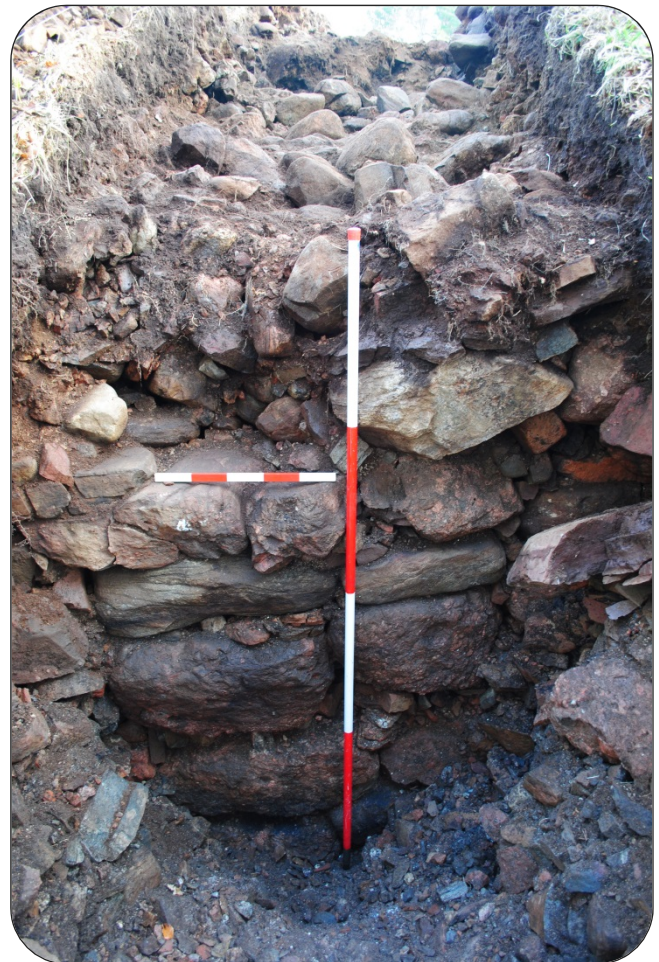
The upper two courses of the outer wall face [010] were found to be displaced outwards. Excavation down the vertical face of the wall for 1.8 metres included the removal of collapsed facing stones and loose rubble (including some large fragments of vitrified material) relating to its destruction (Plate **16**). Near the base of the section more vitrified material, heat-affected stone and some charcoal fragments were identified. This material most likely relates to the burning and collapse of the primary rampart wall, which contained larger areas of vitrification.

Although the base of the outer rampart wall was not entirely exposed, the excavation fully revealed the construction (Figure **7**, Plate **17**). It comprised courses of large boulders, the joints packed with smaller stone clasts and pinning stones. No evidence could be seen in the upper courses for the insertion of horizontal timber lacing, but towards the base of the excavation two courses of large boulders were separated by pinning stones with voids between. These voids may represent the locations of horizontal timbers penetrating the rampart wall. Although some of the facing stones in the wall showed evidence for fire damage, cracking and spalling, none of the stones had been vitrified.

Plate 17: Outer wall face [010], post-excavation facing SE

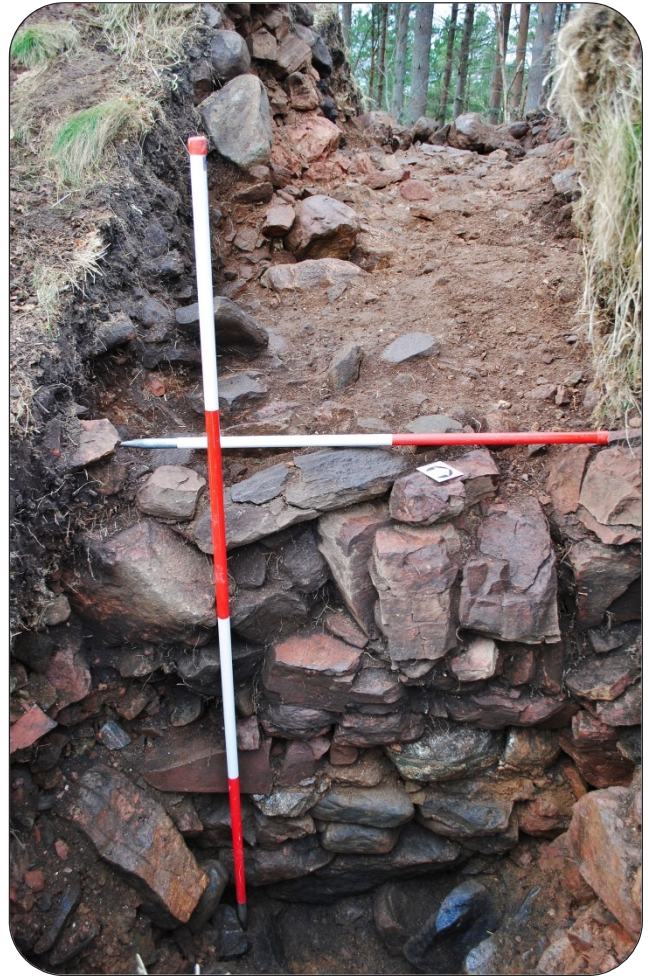
Excavation down the vertical face of the inner wall [013] for 1.6 metres revealed that the construction, though similar to the outer wall face, comprised smaller stones than those used in the external face (Figure **8**, Plates **18-19**). The facing stones showed some heat damage in the form of cracking, but no vitrification. Very little vitrified material was found outside of the inner wall face when compared to the deposits against the outer wall face. The basal course of the inner wall face was not located.

Plate 19: Inner wall face [013], post-excitation, facing NW

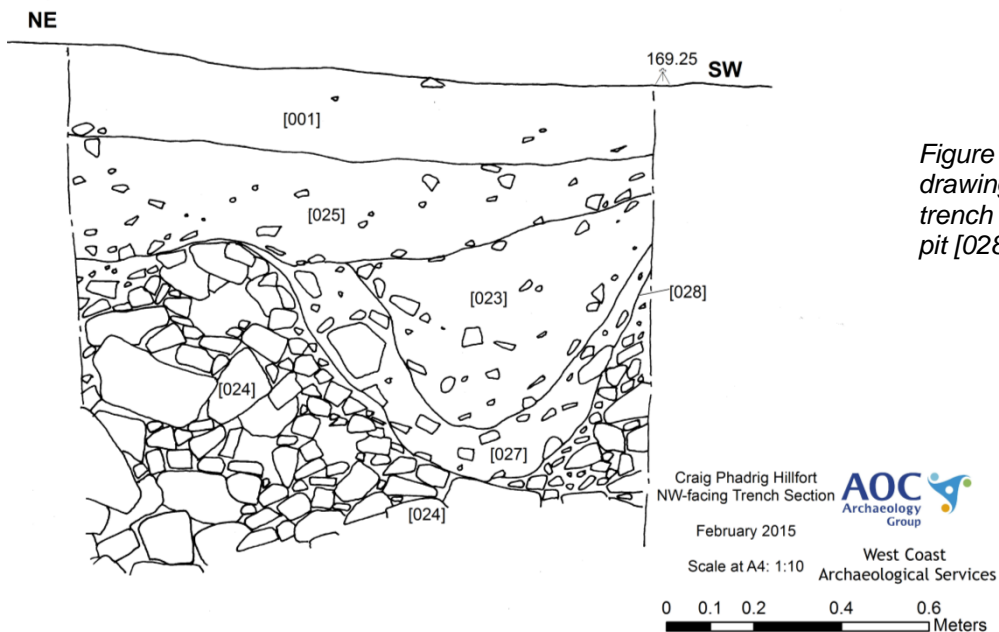
During excavation of the inner wall face, a 'U'-shaped pit was identified in the southeast section of the trench (Figure **9**). This was interpreted as a fire-pit, built into the top of the rubble collapse from the primary rampart wall within the interior of the fort. The dark, charcoal-rich primary fill included what could be an in-situ burnt vertical stake, while the secondary fill comprised a yellow to bright orange ash deposits – possible peat ash. This feature must relate to the secondary occupation of the site.

Figure 9: Section drawing of the SE trench face, showing pit [028]

The possible fire-pit [028] identified in the trench section on the inside of the wall had clearly been dug into collapsed stone on the interior of the rampart, post-dating the primary use of it. The content of the two separate fills of charcoal-rich ash and peat-ash are not dissimilar to the description of the 1971 upper occupation layer containing significant quantities of animal bone, ash and peat ash (Small and Cottam 1972). These deposits were found in association with a small structure related to secondary occupation within the interior of the rampart. Along with the finds of E ware pottery and the escutcheon mould in this layer, this extended the occupation evidence to late Pictish period (RCAHMS 2015).
