## CLACHTOLL BROCH PROJECT

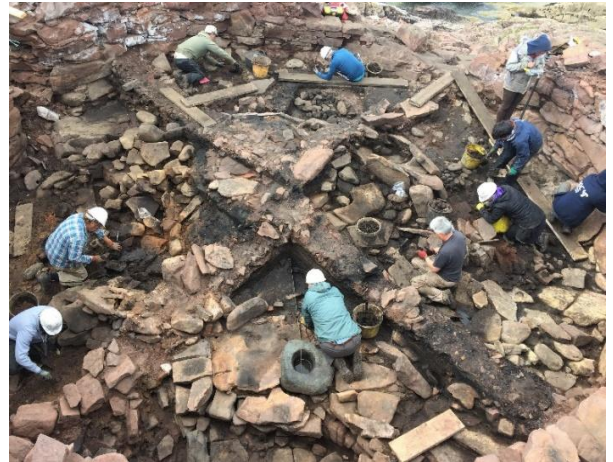
- A mounded area of the destruction layers a little to the west of centre overlay the uppermost of three hearths suggesting that there had been a hearth on the bedrock from a very early stage in the broch's occupation. The topmost hearth would have been very close to the first floor if that extended across the full width of the interior.

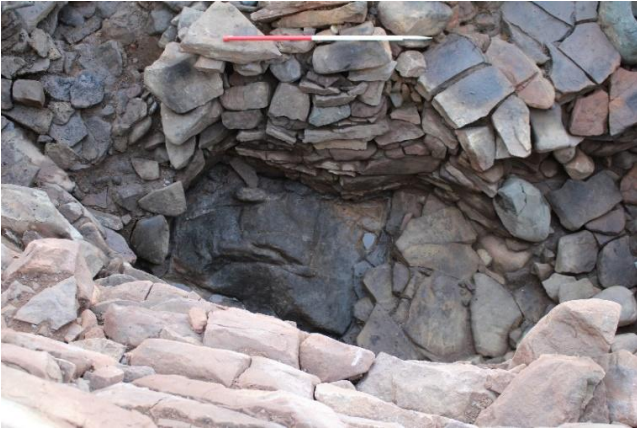
- Beside the hearth were the remains of a probable water tank and at lower levels the suggestion of some kind of channel running between the tank and the entrance.
